FEASIBILITY OF FRM FOR THE RECONSTRUCTION OF AN ANCIENT ROMAN TEMPLE

Ece Erdogmus, PhD
Catherine Armwood

University of Nebraska-Lincoln
Architectural Engineering Program

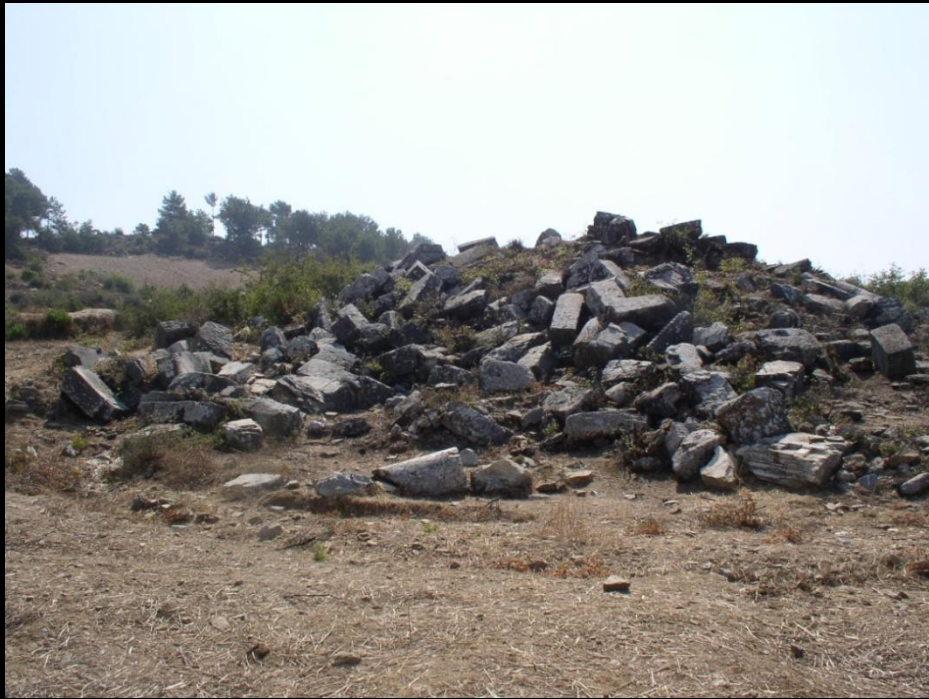
2005-Collapsed State of the Temple

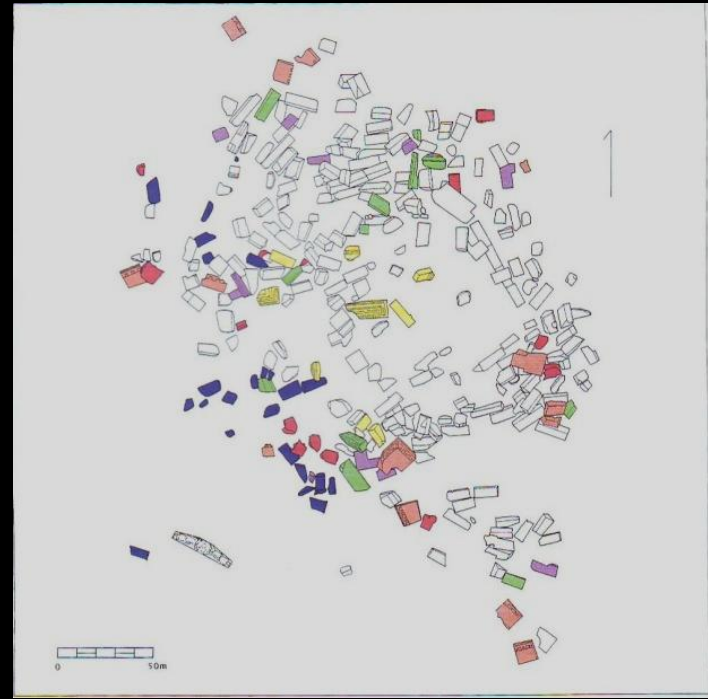
2005-State Plan with
270 surveyed blocks on
the surface

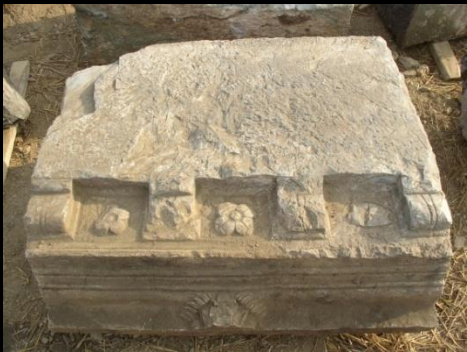
1

Marble block assessments

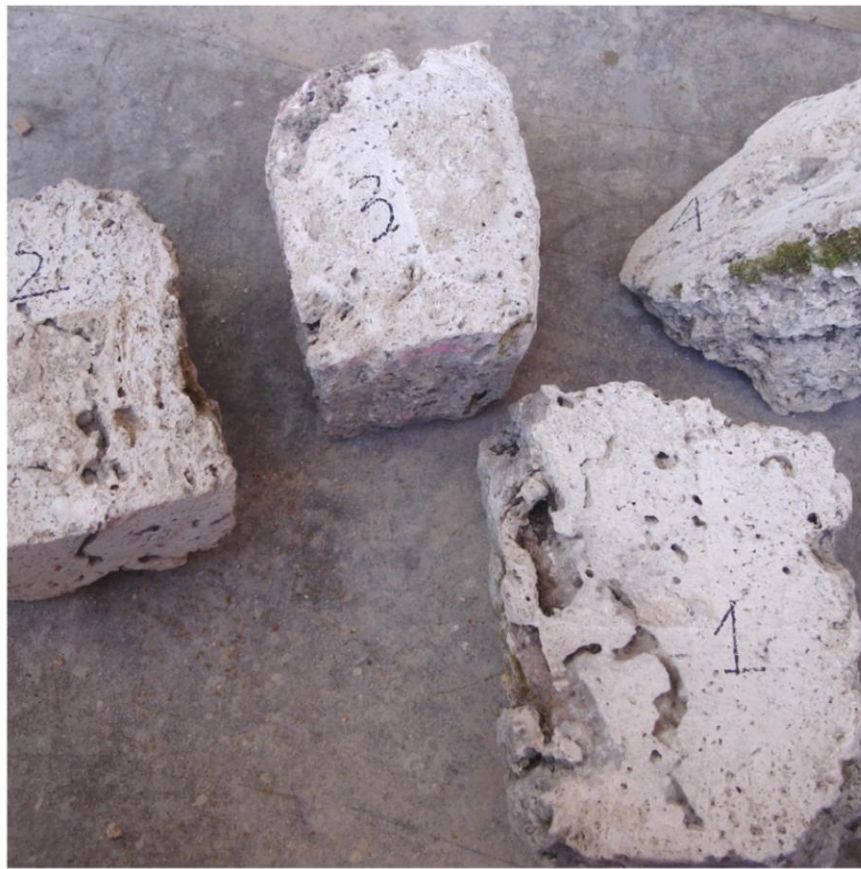
Samples used in
the mechanical
and chemical tests

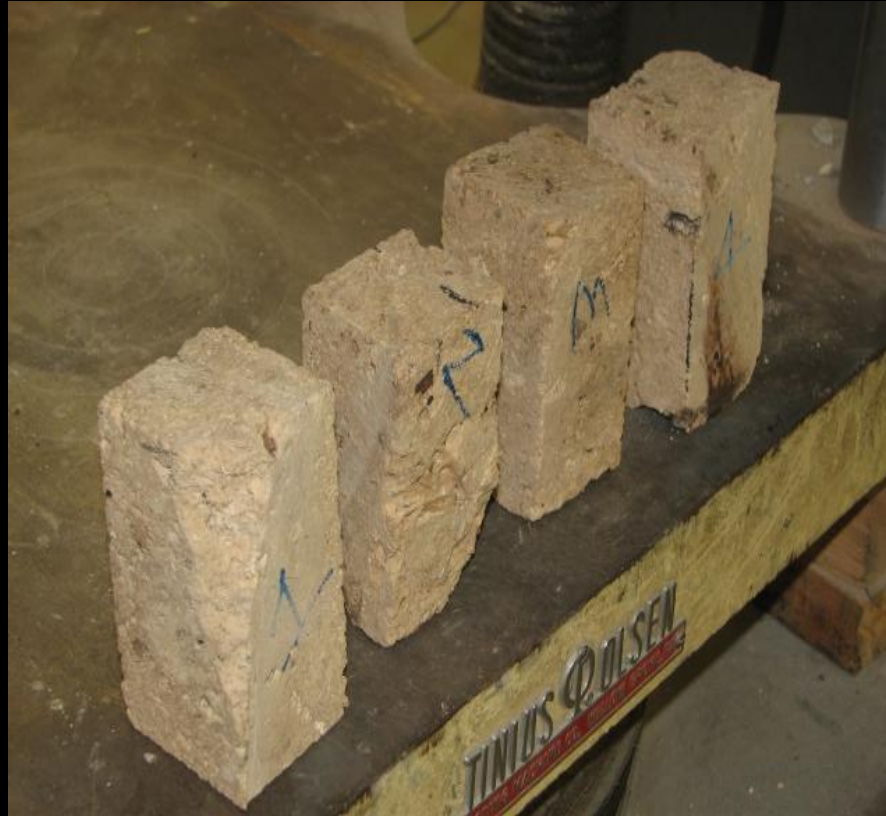
Mortar samples for Compressive test
(2in x 2in x 4in = 5 cm x 5cm x10 cm)

Specimen #	T-R-C1-08	T-R-C2-08	T-R-C3-08	T-R-C4-08
Area	(in ²)	4	4	4	4
	(cm ²)	25.8	25.8	25.8	25.8
Weight	(lb)	0.891	0.799	0.977	0.9375
	(N)	3.96	3.56	4.35	4.17
P _{max}	(lb)	2,980	2,320	1,740	1,970
	(N)	13,261	10,324	7,743	8,767
Comp. strength (f' _c)	(psi)	745	580	435	492
	(Mpa)	5.14	4.00	3.00	3.39

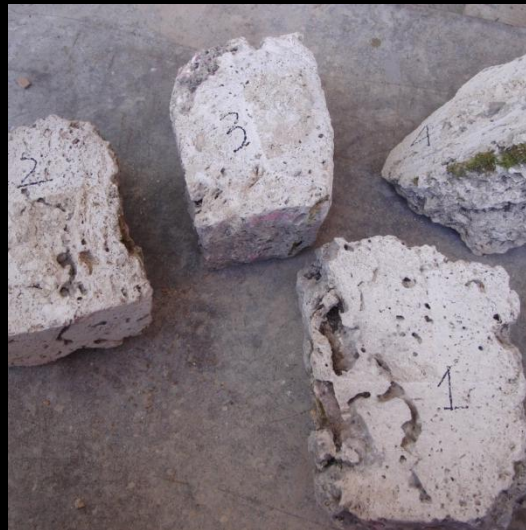
- Mortar in general light grey comparable to Munsell 2.5Y-8/1 to 7/1.
- The colour of the sand (Munsell based): 2.5Y-7/1 to 6/1
- The colour of the fines (Munsell based): 2.5Y-7/2
